Protemp™ 4

Temporisation Material

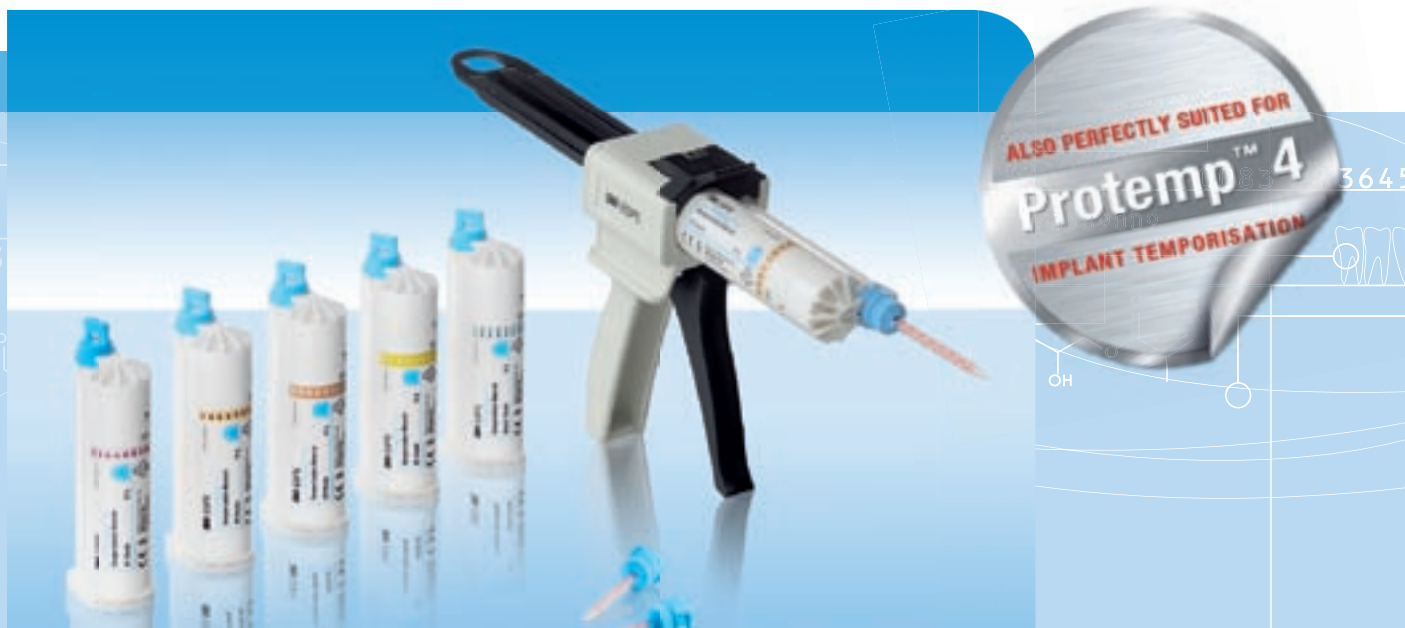
Clinical case studies from around the world

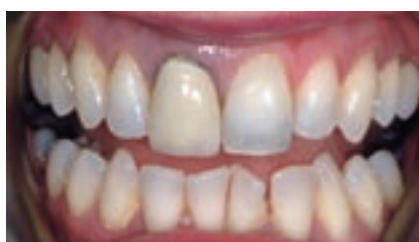
Fig. 1: Pre-operative view. Insufficient single-unit crown on tooth UR1 with exposed metal margins.

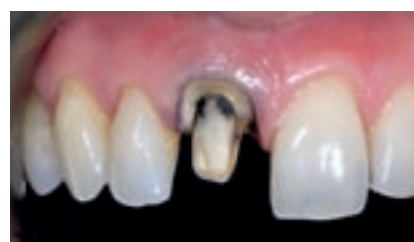
Fig. 3: Completed tooth preparation showing the margin with gingival retraction in situ. Note the discolouration of the tooth due to leakage around the PFM crown margins.

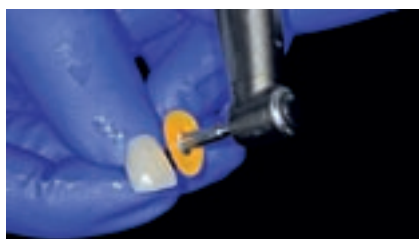
Fig. 5: Adjusting the occlusion and final polish.

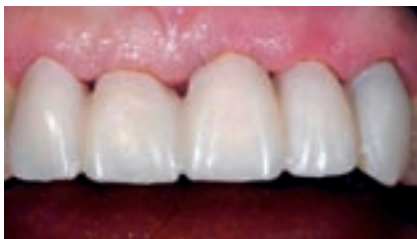
Fig. 5: View of Protemp™ 4 Temporaries after 14 days wearing time.
